123 SYCAMORE STREET  
BREMERTON, WA. 98310

Beacon Home Inspections  
**INSPECTION REPORT**

Address: 123 SYCAMORE STREET, BREMERTON WA 98310

Date: 1/1/2022

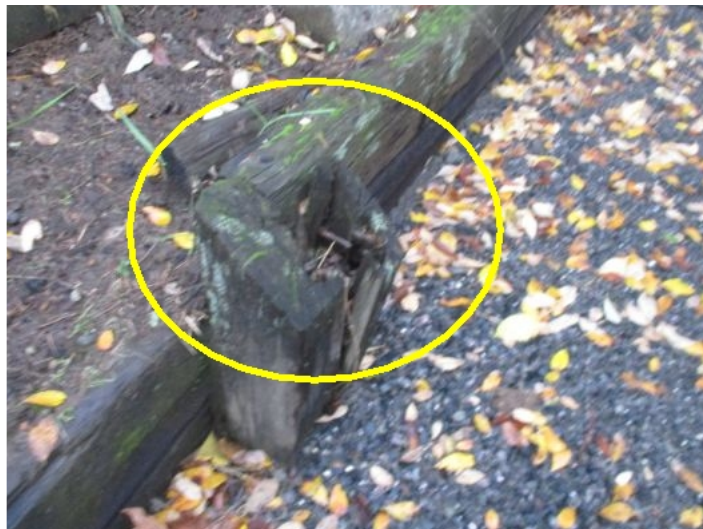
- Wood retaining wall at rear of house leans toward house. Wall appears to function as intended.
- Observed deteriorating posts at wood retaining wall on left side of house.

Rotted post at left retaining wall

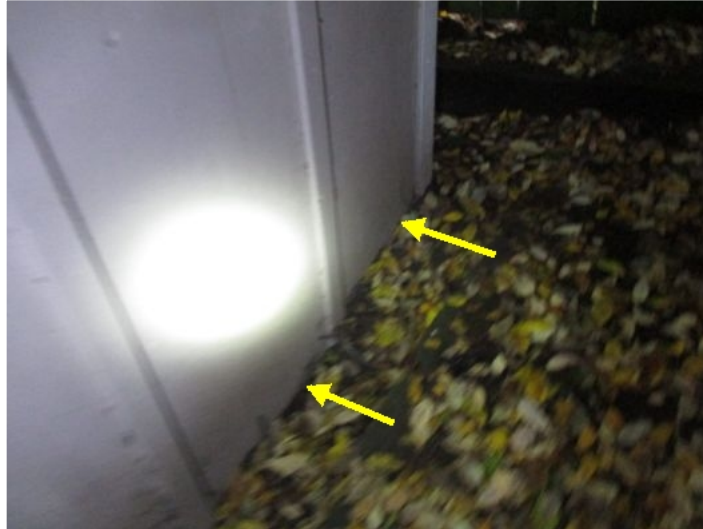
- Observed wood to ground contact at exterior walls. Wood in contact with the ground tends to absorb moisture and deteriorate prematurely.

Wood to ground contact at shed siding

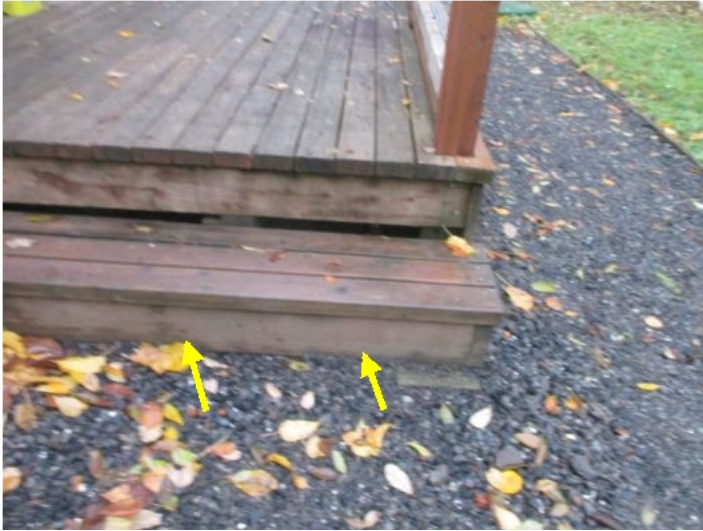
- Wood to ground contact observed at both decks. Wood in contact with the ground tends to absorb moisture and deteriorate prematurely. Recommend clearing away soil from sides of steps.

Wood to ground contact at front deck

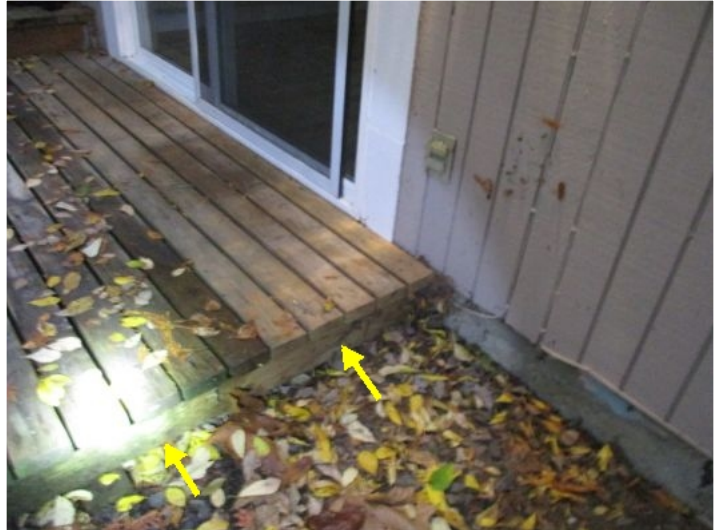
Wood to ground contact at rear deck

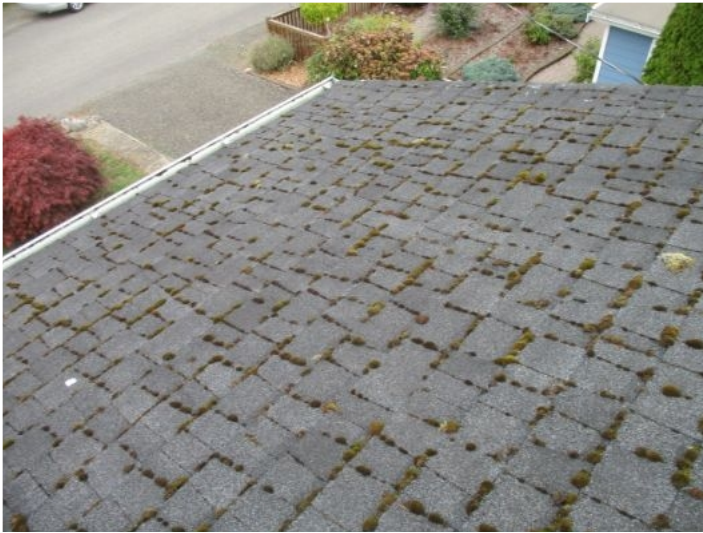
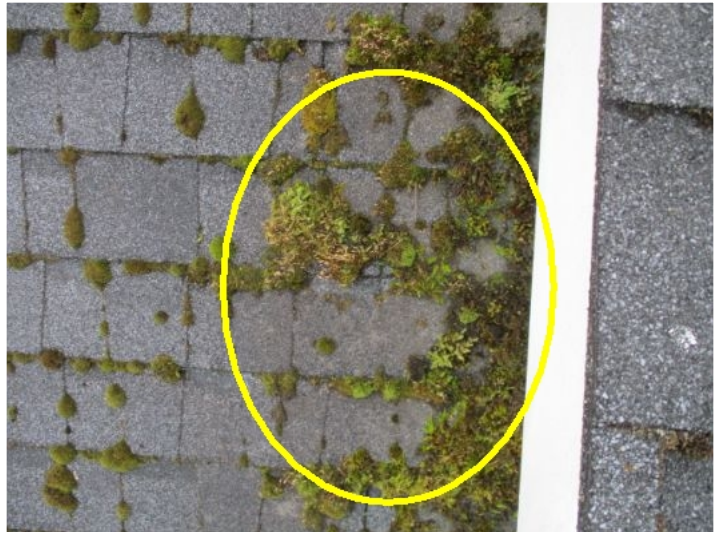
- I recommend further evaluation by roofing contractor.
- Observed moss on roof. This can lead to the premature failure of the roof and subsequent leaks. Recommend treating moss with a moss killer.
- Several areas of granular loss observed.

Moss growth on roof

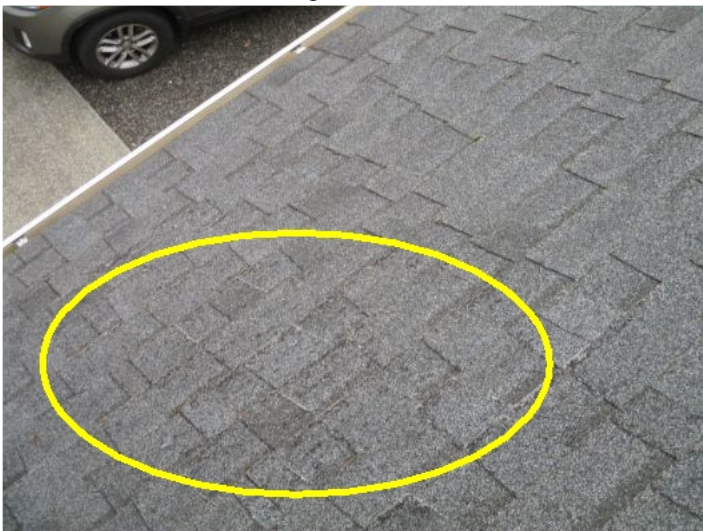
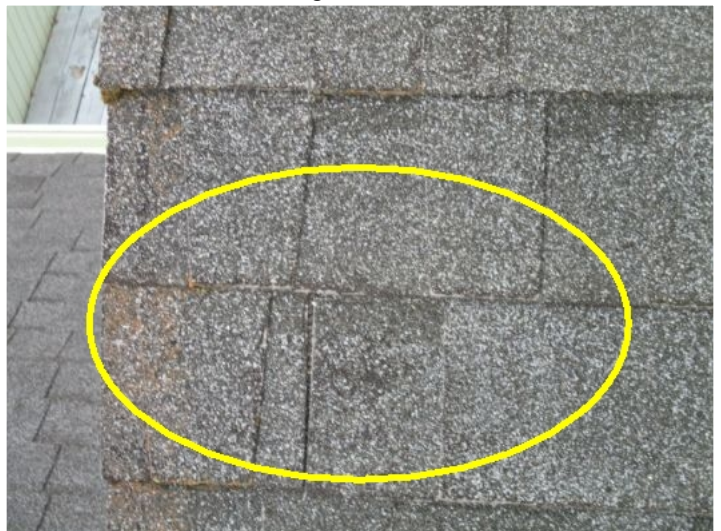
Granular loss on shingles

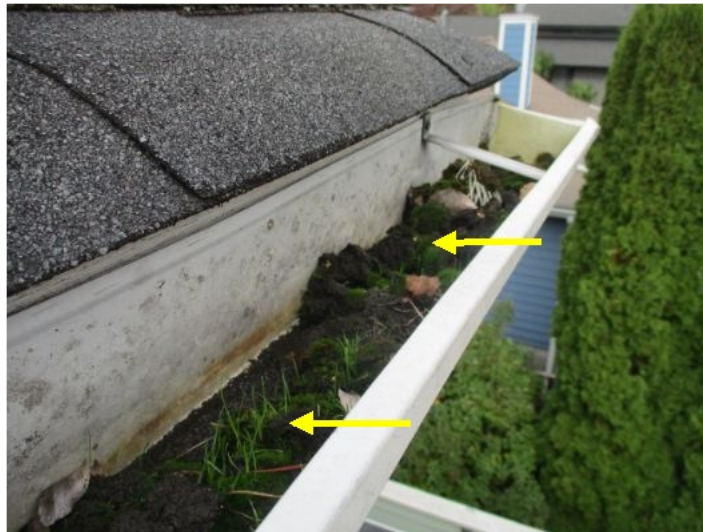
- Observed gutters clogged with organic debris. Recommend cleaning gutters for efficient drainage.

Observed gutters full of organic debris

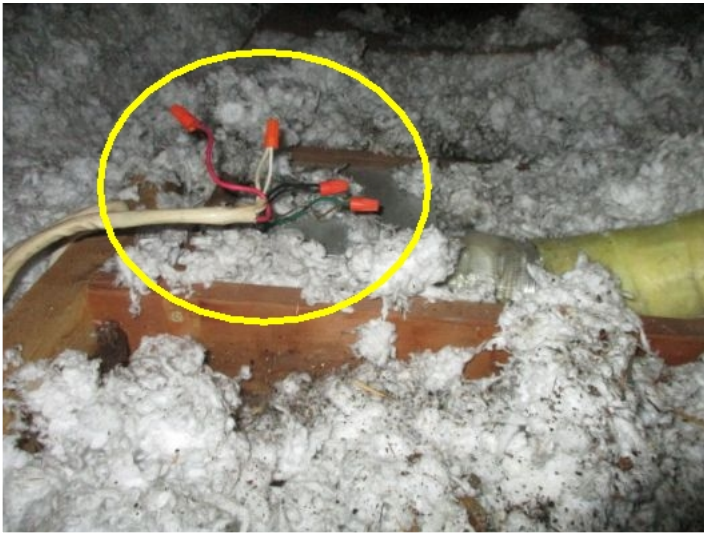
- I recommend further evaluation by licensed electrician. Observed two open electrical splices for bathroom vent fans. Observed one improperly terminated live wire. Electrical splices and live wires should be capped with wire nuts and terminate in a junction box. Exposed splices in attic spaces are considered fire hazards.

Open electrical splice in attic

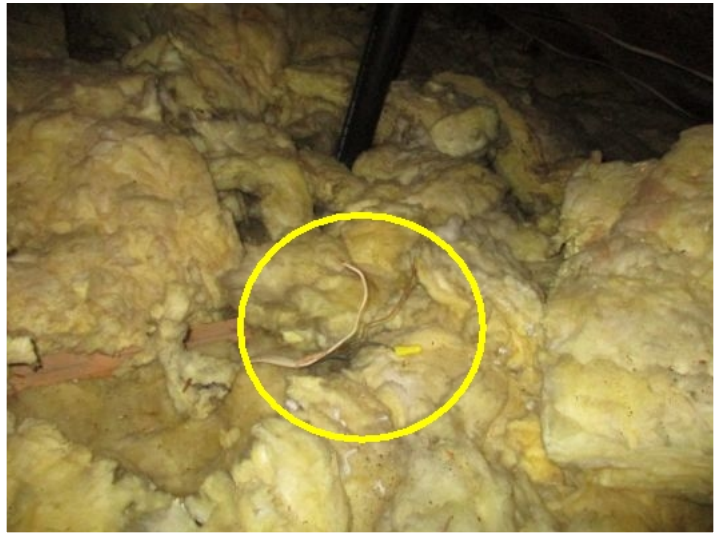
Open live wire in attic

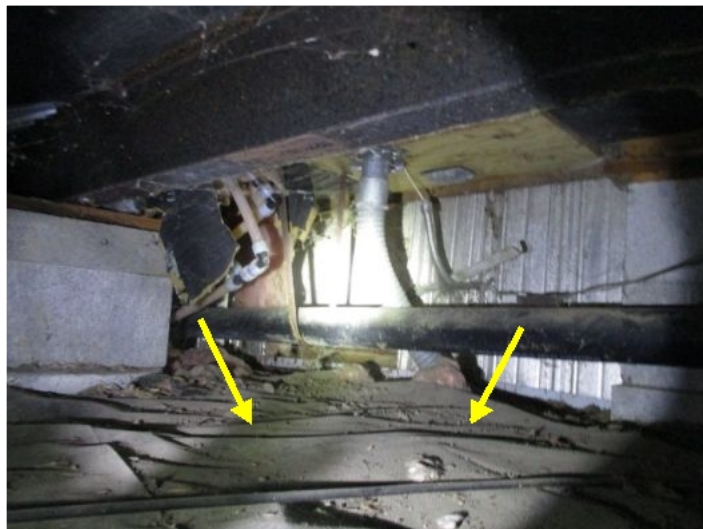
- Crawl space is missing vapor barrier in some areas. Vapor barrier was bunched up or pushed back in several areas. Recommend re-spreading vapor barrier to ensure complete coverage.

Exposed soil in crawl space

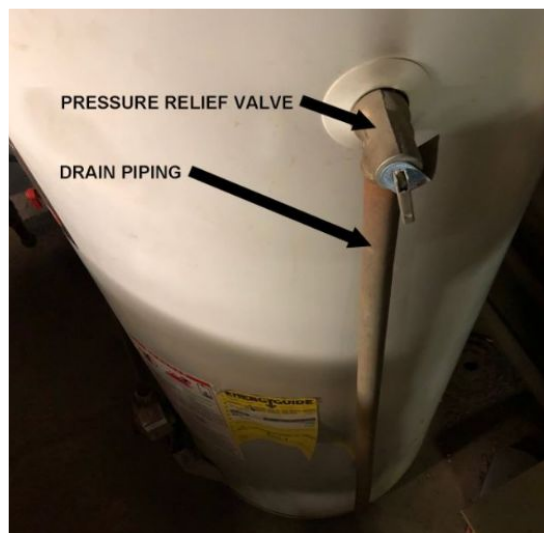
- Improper relief line observed. Relief line is made of flexible copper piping. A smooth copper pipe or CPVC drain line is required.

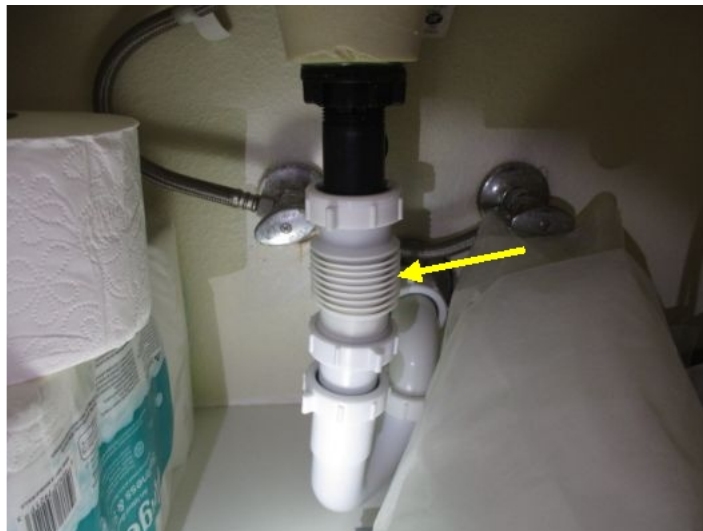
- Accordion style flex drain line observed. This style of drain is not permitted since it is prone to clogging. Smooth wall drain pipe is required.

Flex style drain pipe in south bathroom
