123 SYCAMORE STREET  
BREMERTON, WA. 98310

Beacon Home Inspections  
**INSPECTION REPORT**

Address: 123 SYCAMORE STREET, BREMERTON WA 98310

Date: 1/1/2022

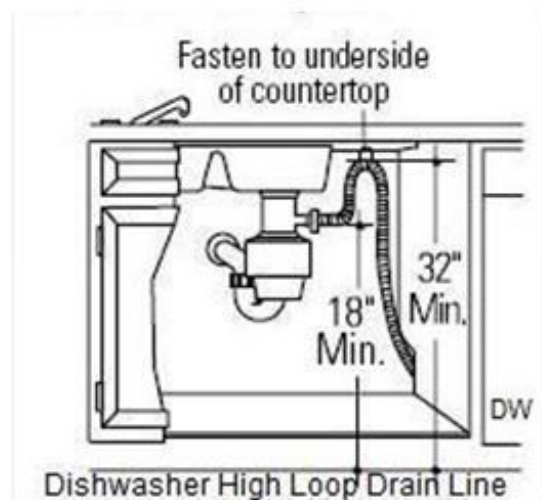
- Observed lack of back flow prevention. A "high-loop" prevents sink water from draining back to the dishwasher and possibly to the floor.

Example: Dishwasher backflow prevention setup
